# FEASIBILITY OF ALTERNATIVES TO THE GOAT ROCK STATE BEACH JETTY FOR MANAGING LAGOON WATER SURFACE ELEVATIONS

Prepared for  
Sonoma County Water Agency

March 10, 2017

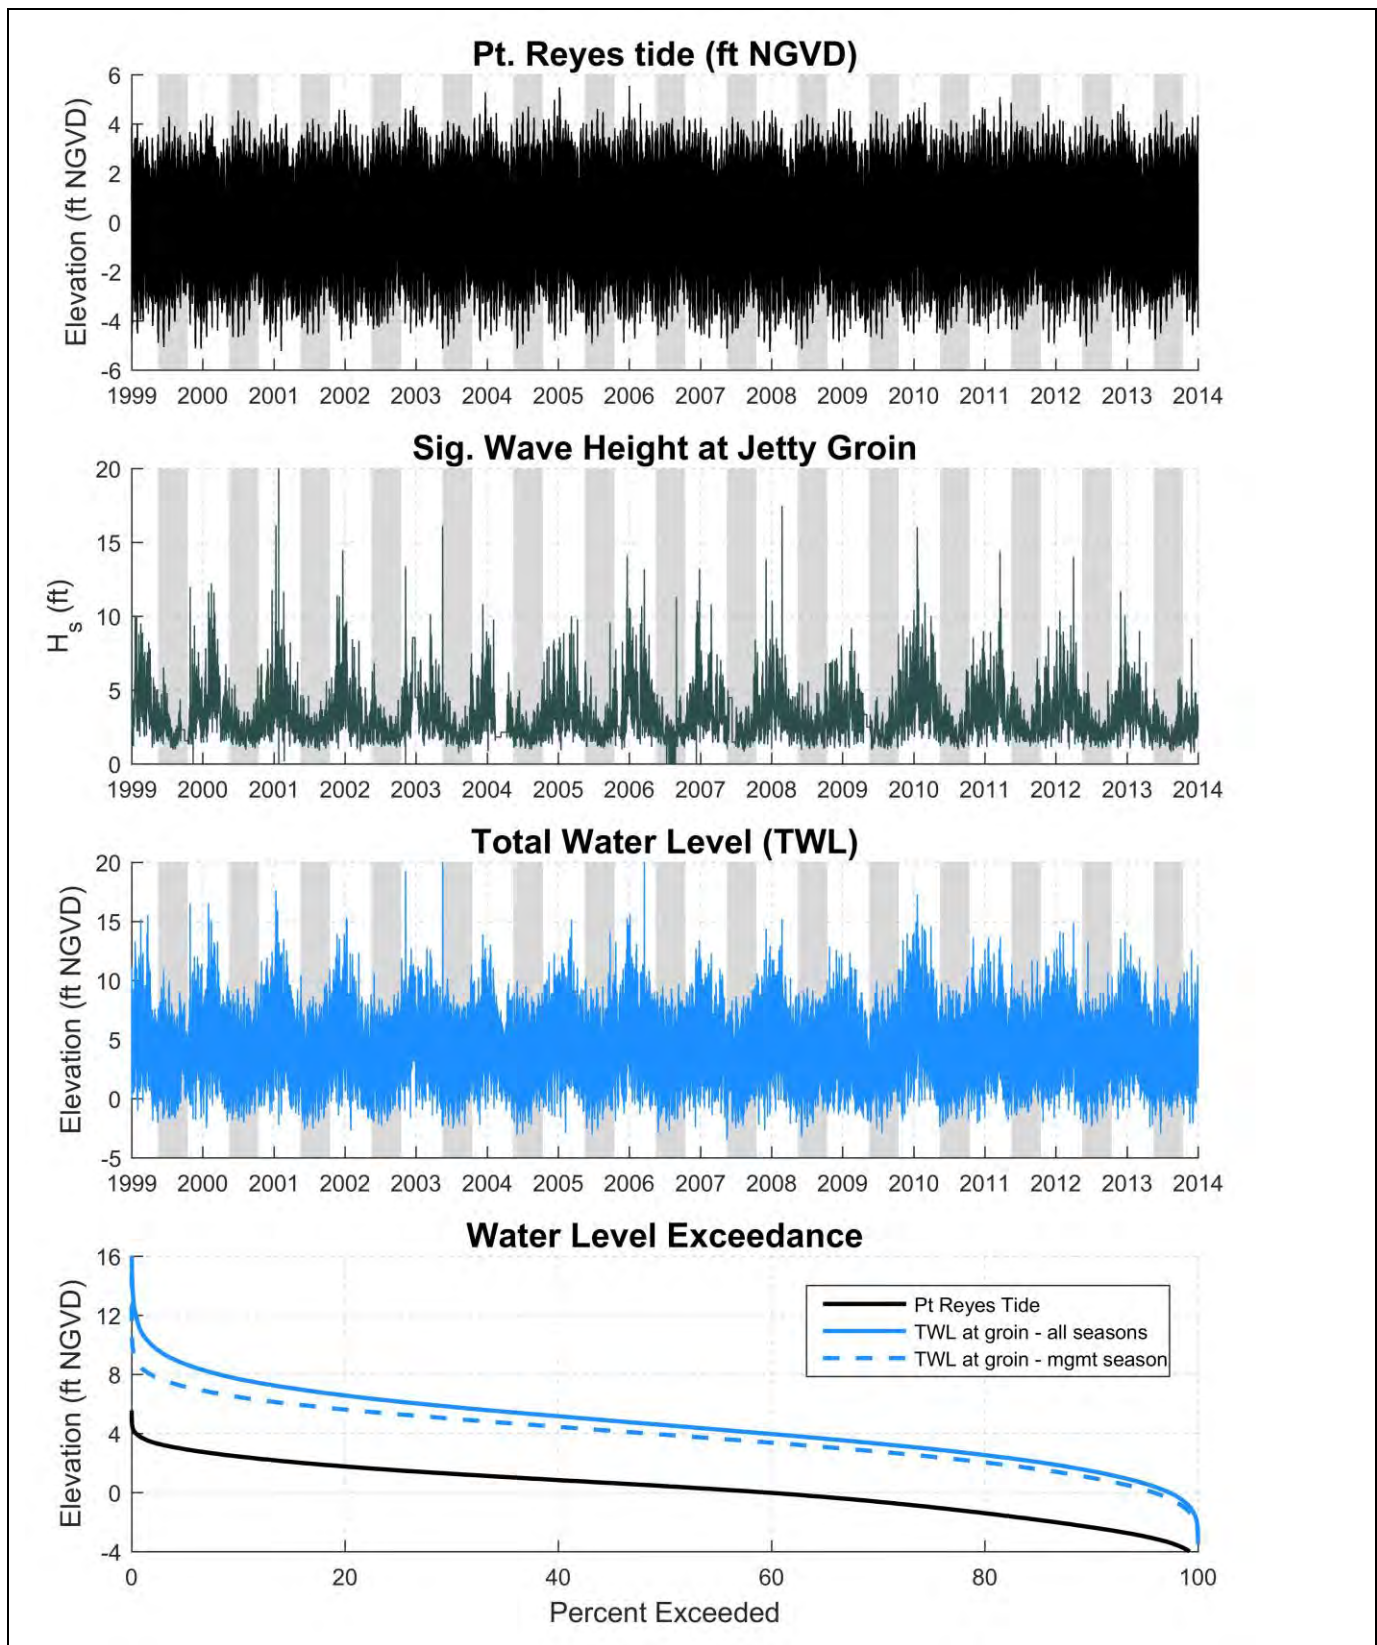
Summary of tide, wave, and total water level conditions at the jetty groin, for 2000-2014.

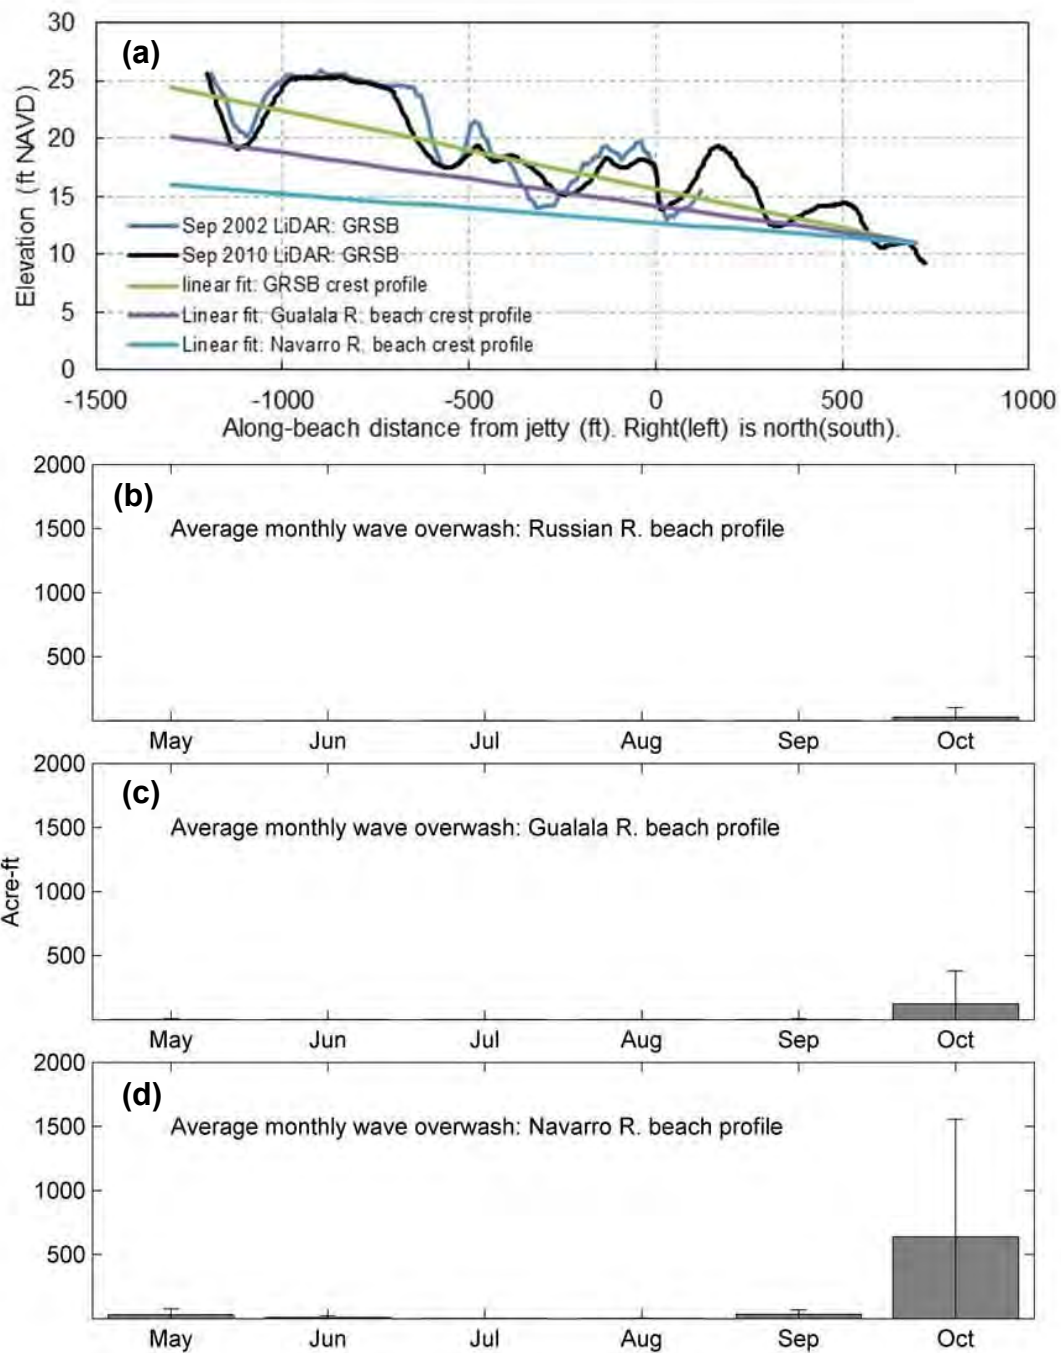
**Figure 4-9**

NOTE: Average monthly wave overshaw volumes calculated using nearshore wave estimates from January 1997 to December 2011.  
Linear fit of GRSB beach profile in upper panel is a fit of 2010 LiDAR.

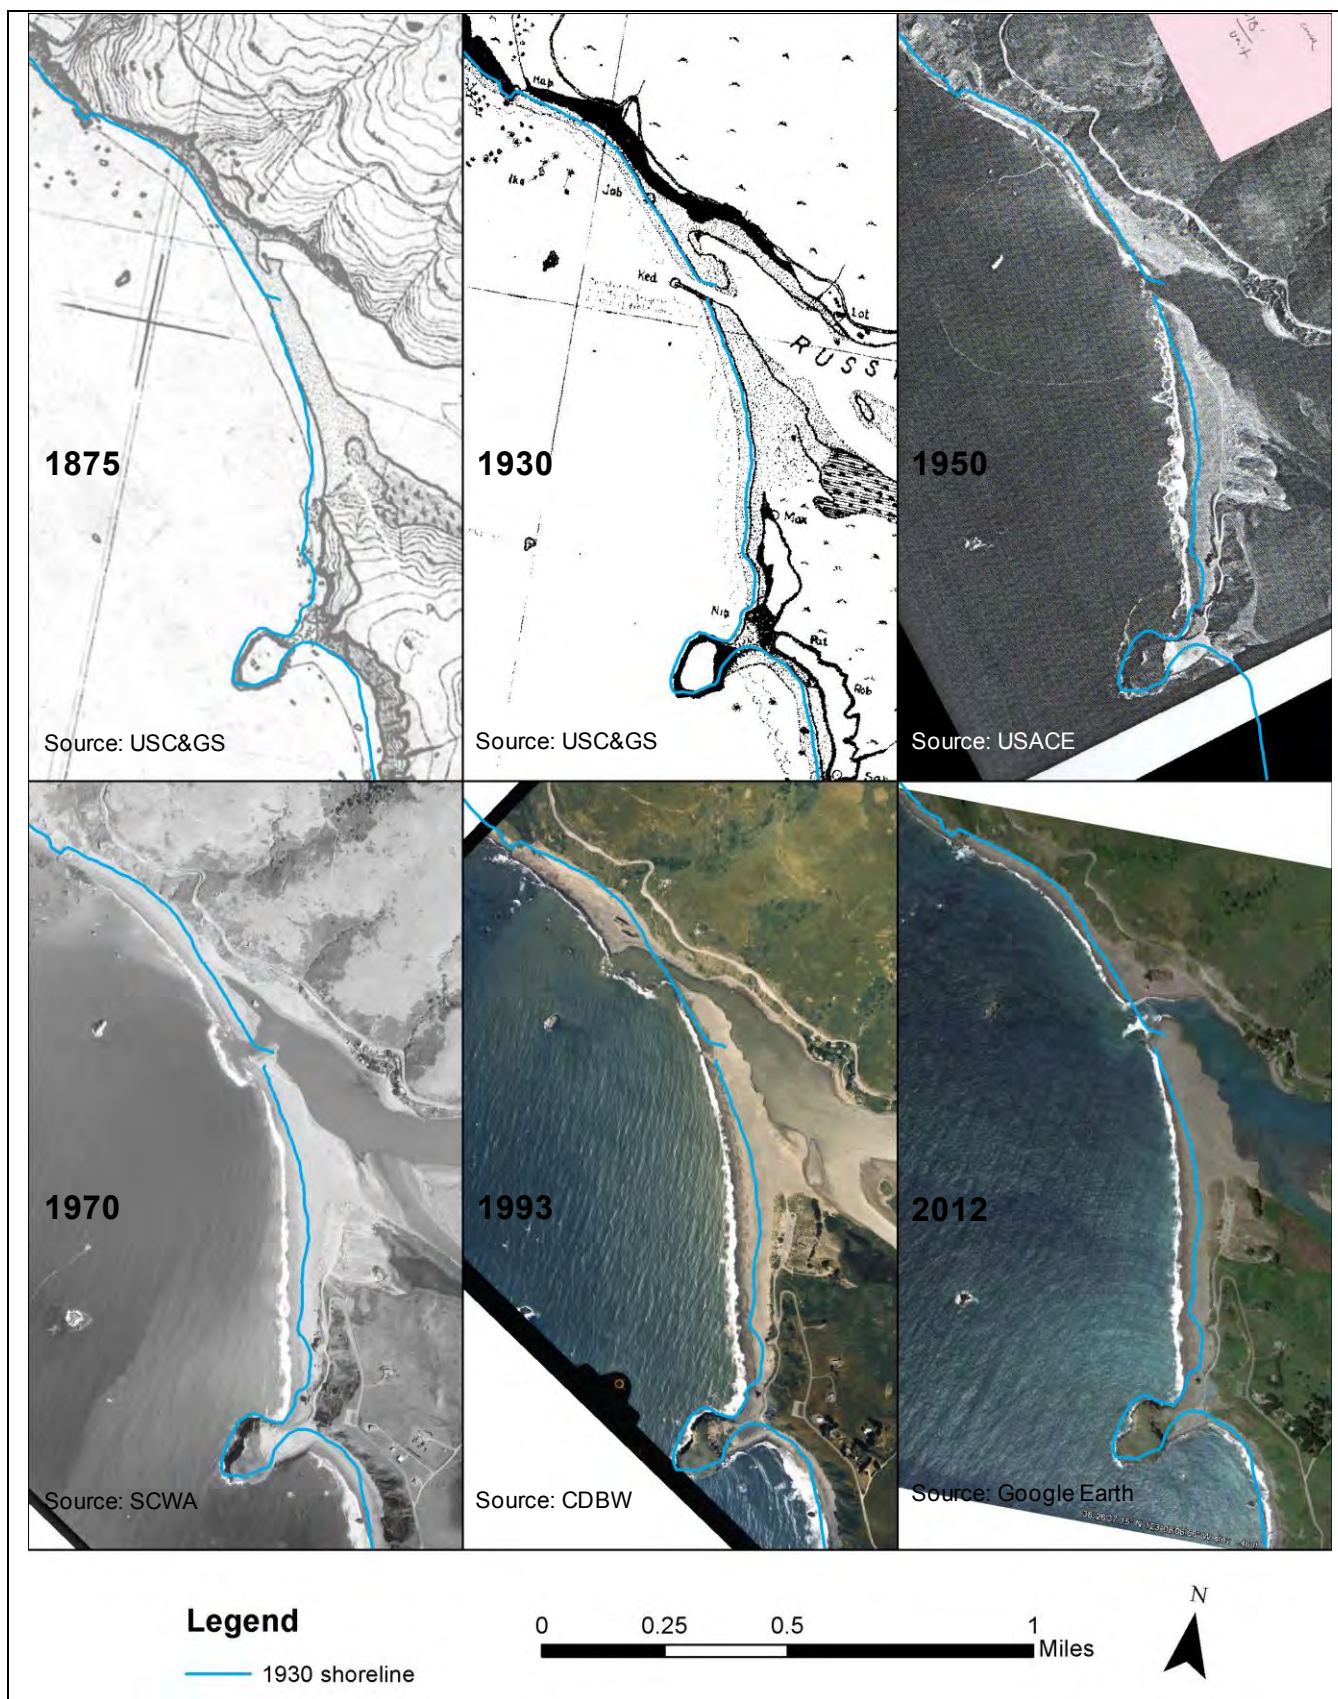
**Figure 5-1**

NOTE: Bars shown in insets represent transects used in the analysis of historical images. Background image in all panels is an orthophoto taken in 2009 by the USDA NAIP.

Aerial view of the Russian River Littoral Cell, with insets of beaches analyzed with historical aerial images.

For the part of GRSB north of the groin and beyond the extent of typical inlet migration (Transects 1-4 in Figure 5-1), sea level rise would result in a retreat of the beach into the backbarrier cliffs, which would also undergo erosion from extreme wave events (Sallenger et al. 2006). This would also happen where dunes back the beach between the Beach Parking Lot and Goat Rock (Transects 8-16 in Figure 5-1).

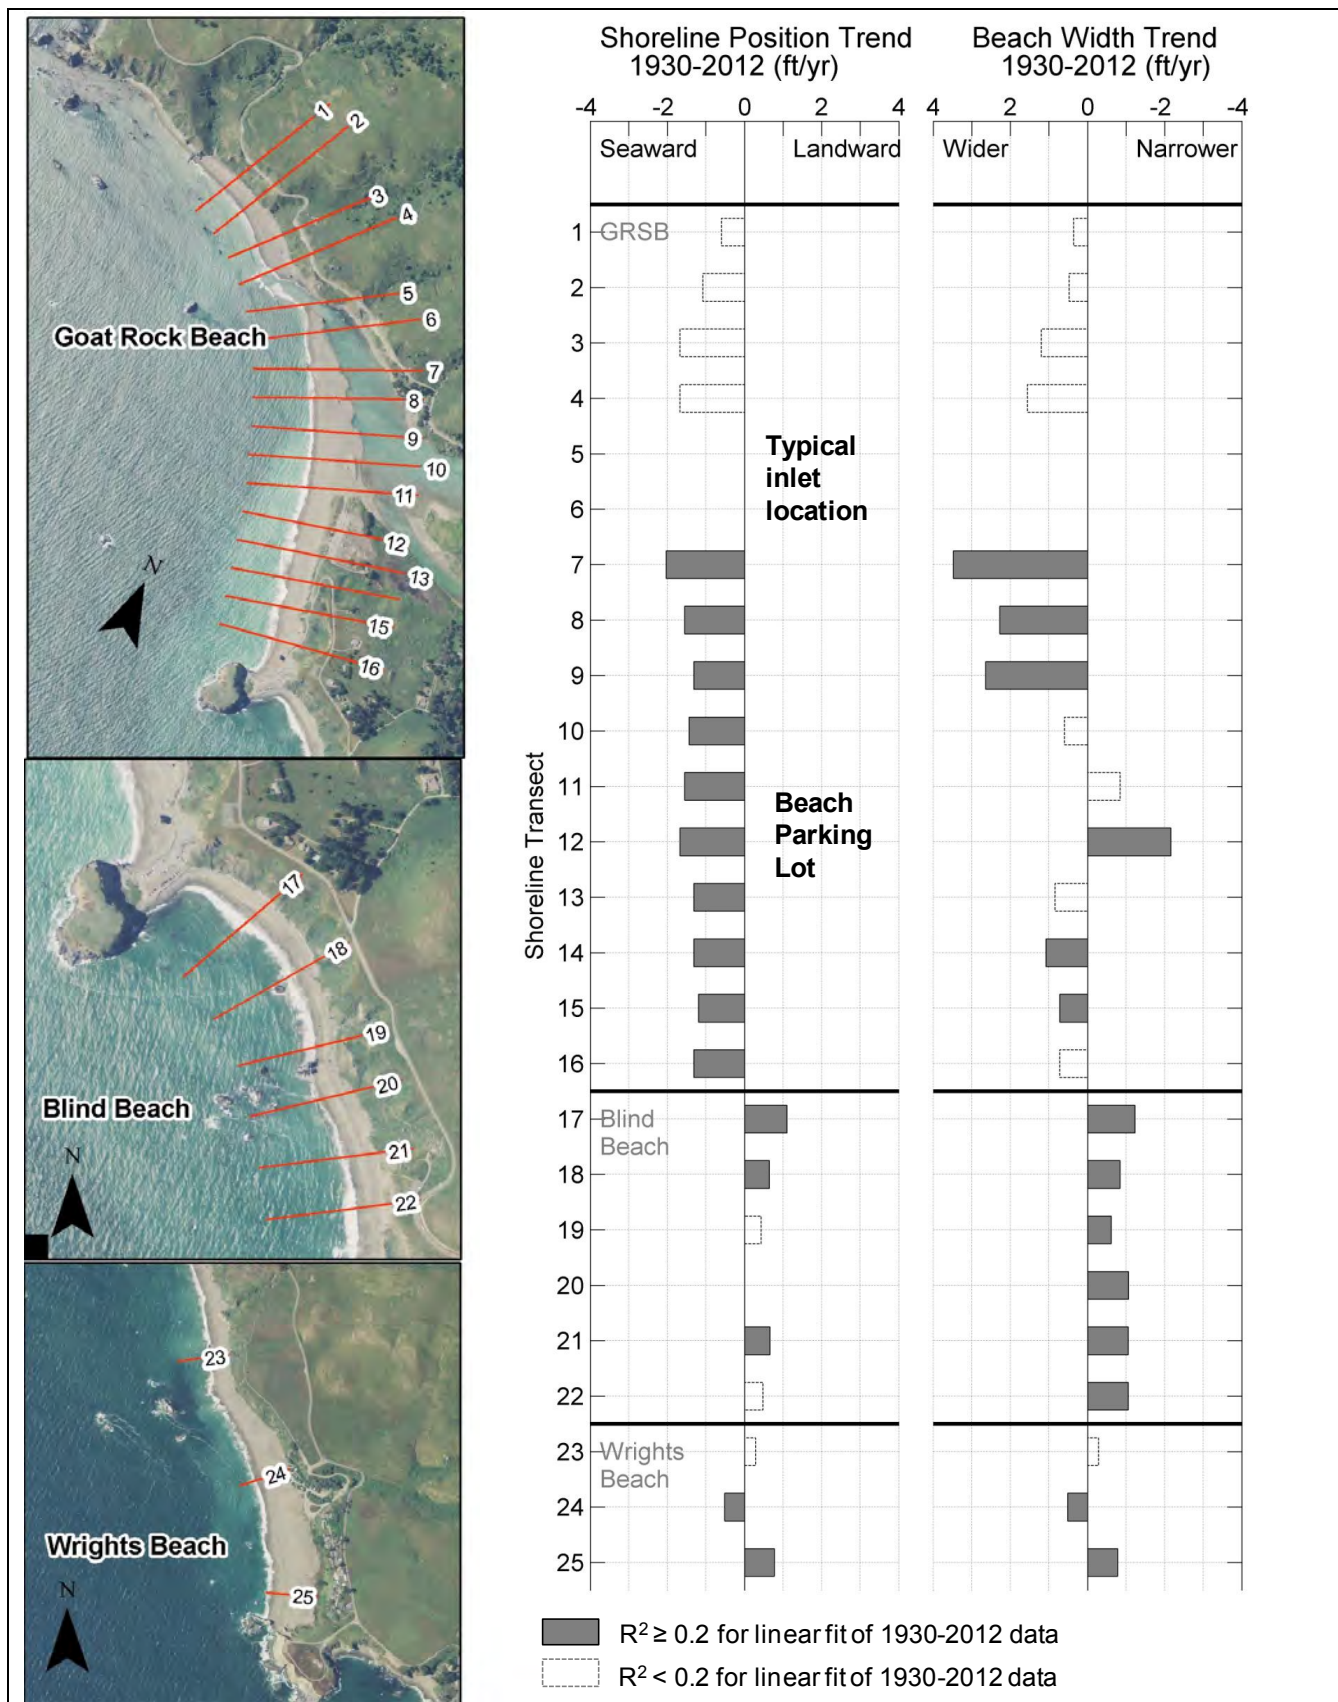
**Figure 5-3**  
(left) Beach transects and (right) corresponding trends in shoreline position and beach width

NOTE: All linear trends were obtained using DSAS with a linear fit of the data. Data and trend lines are given in a separate appendix

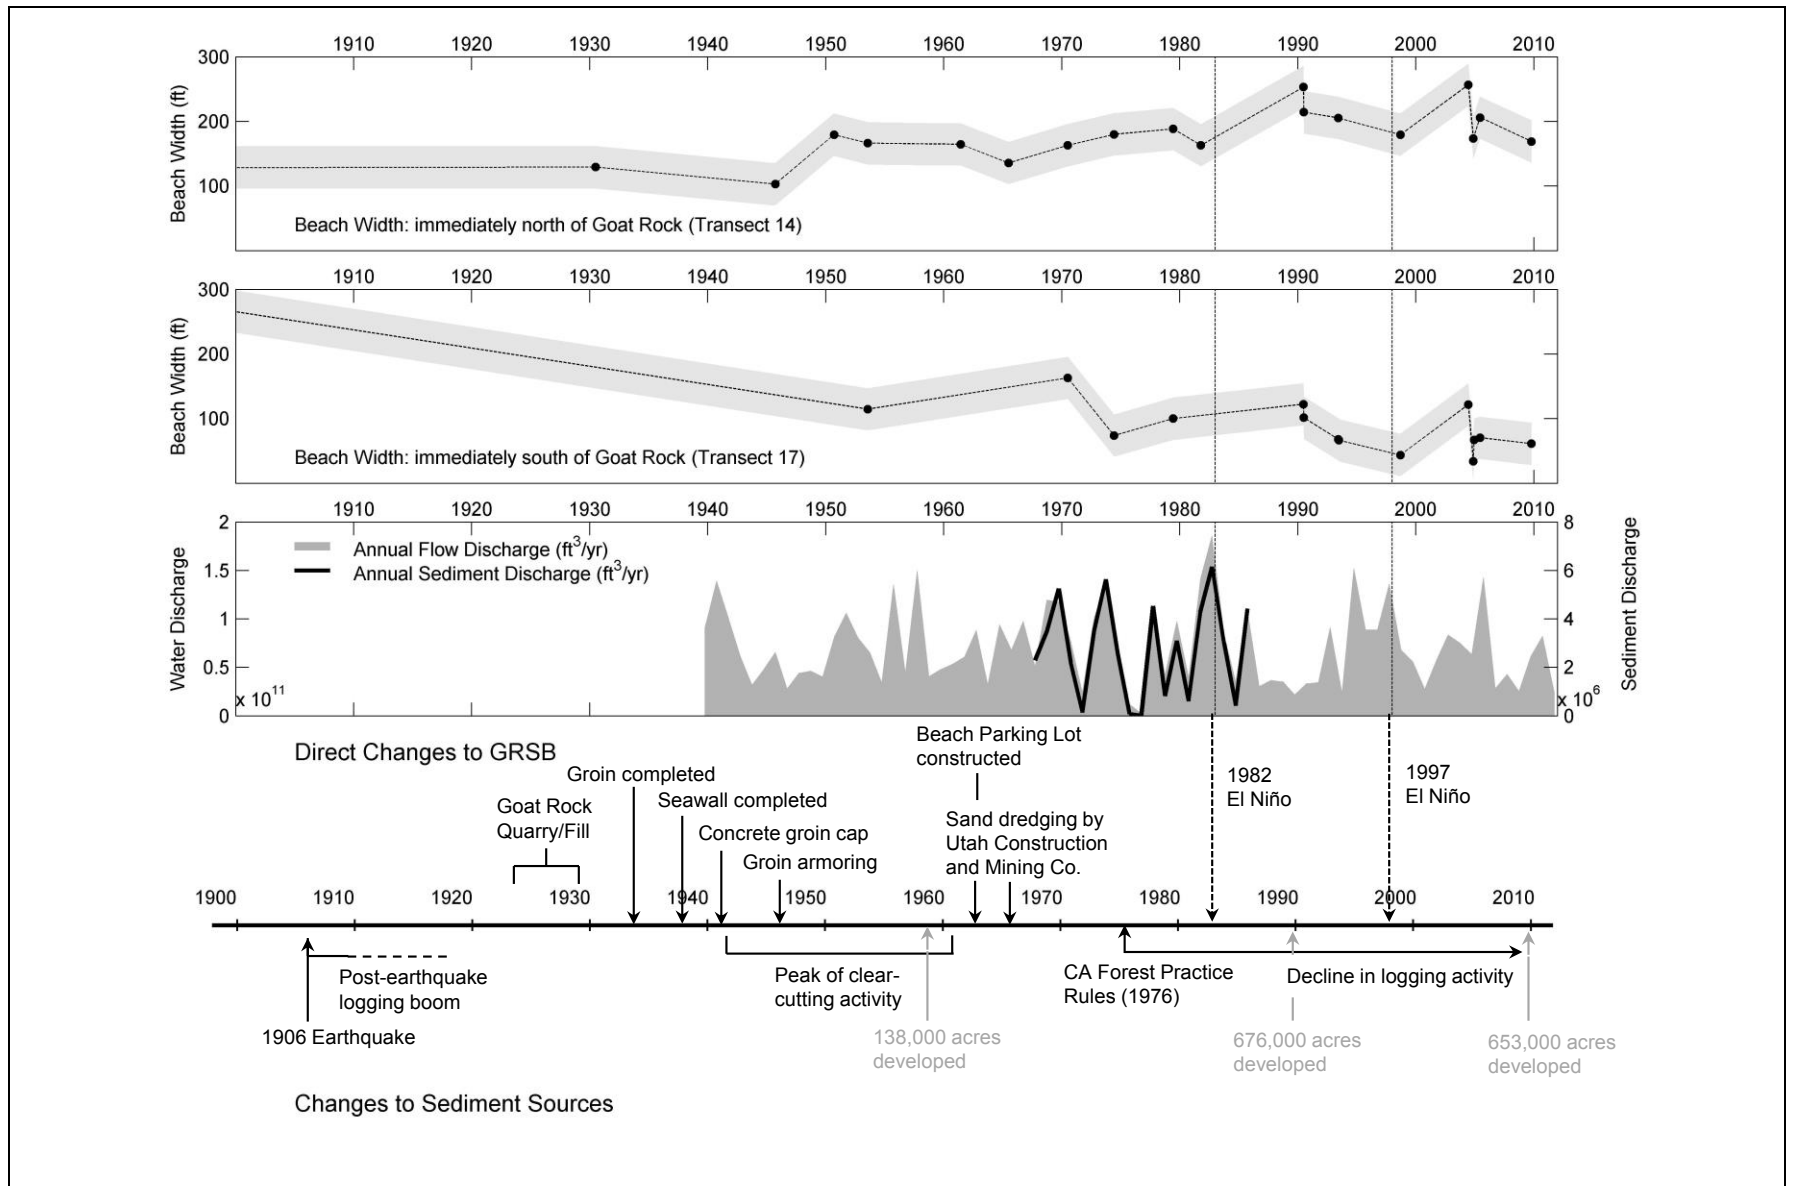
**(upper panels)** Time series of beach width north and south of Goat Rock, compared against **(mid panel)** river and sediment discharge and **(bottom panel)** changes to beach and sediment supply

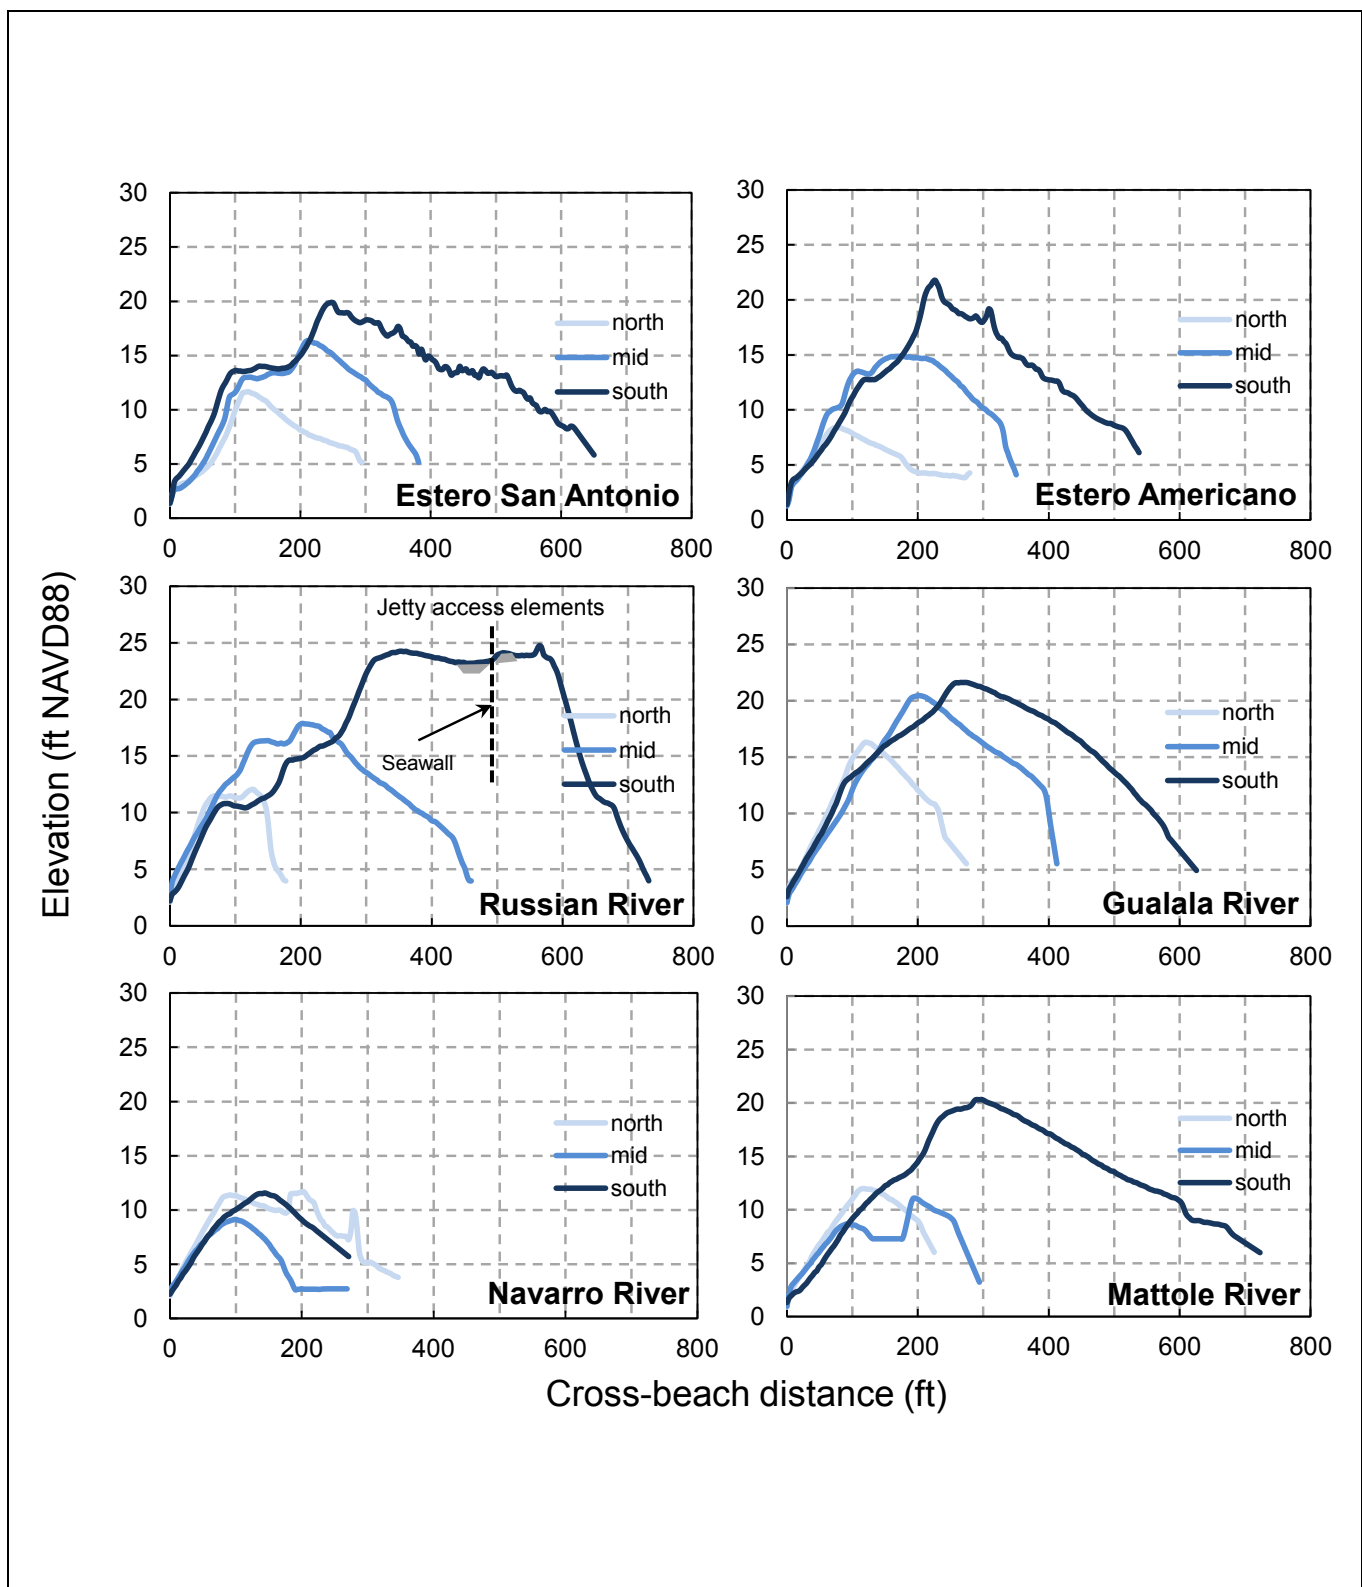
NOTE: Transects were only taken on the spit between the estuary and ocean at each site. Sites were chosen based on similarity to the Russian River Estuary. All sites are located within 200 mi. of GR SB.

Beach transects from the GR SB and five reference sites, using September 2010 LiDAR data.

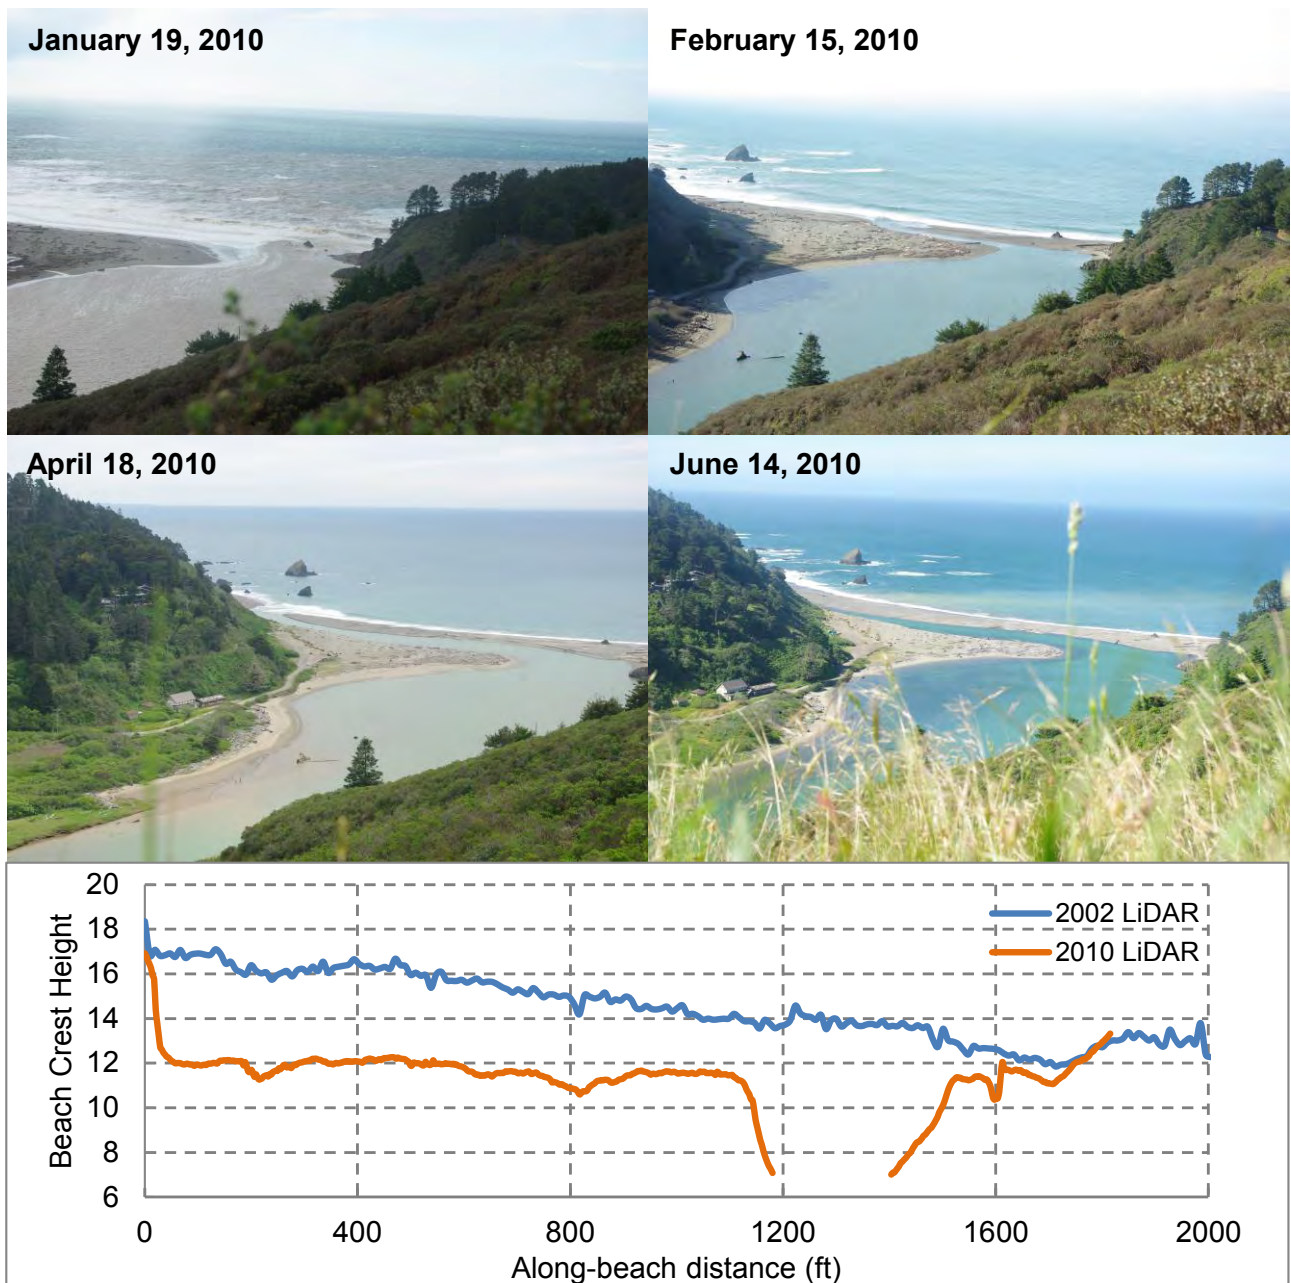
**Figure 5-5**

SOURCE: Images provided by D. Behrens. Beach crest profiles extracted from LiDAR data collected by CCC (2012)

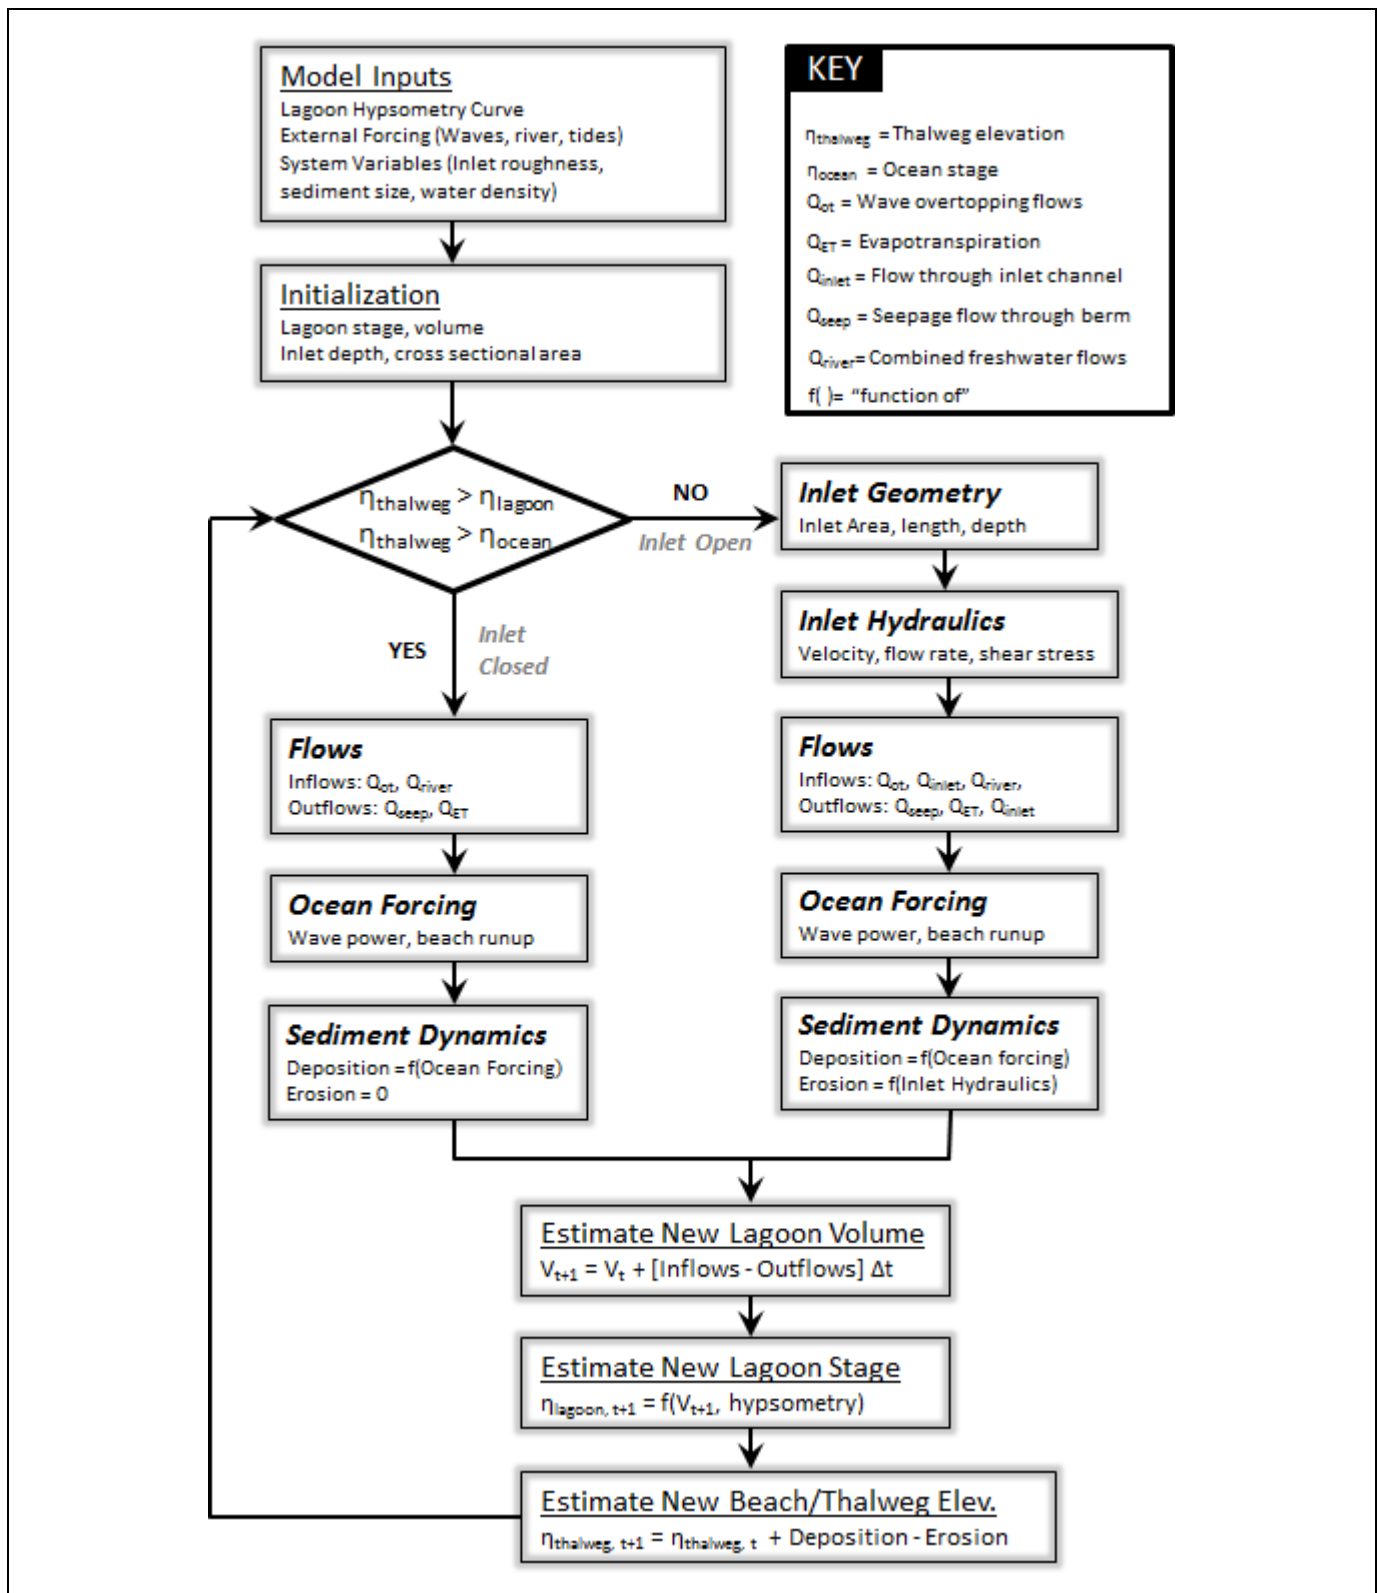
Flow chart of the lagoon quantified conceptual model.

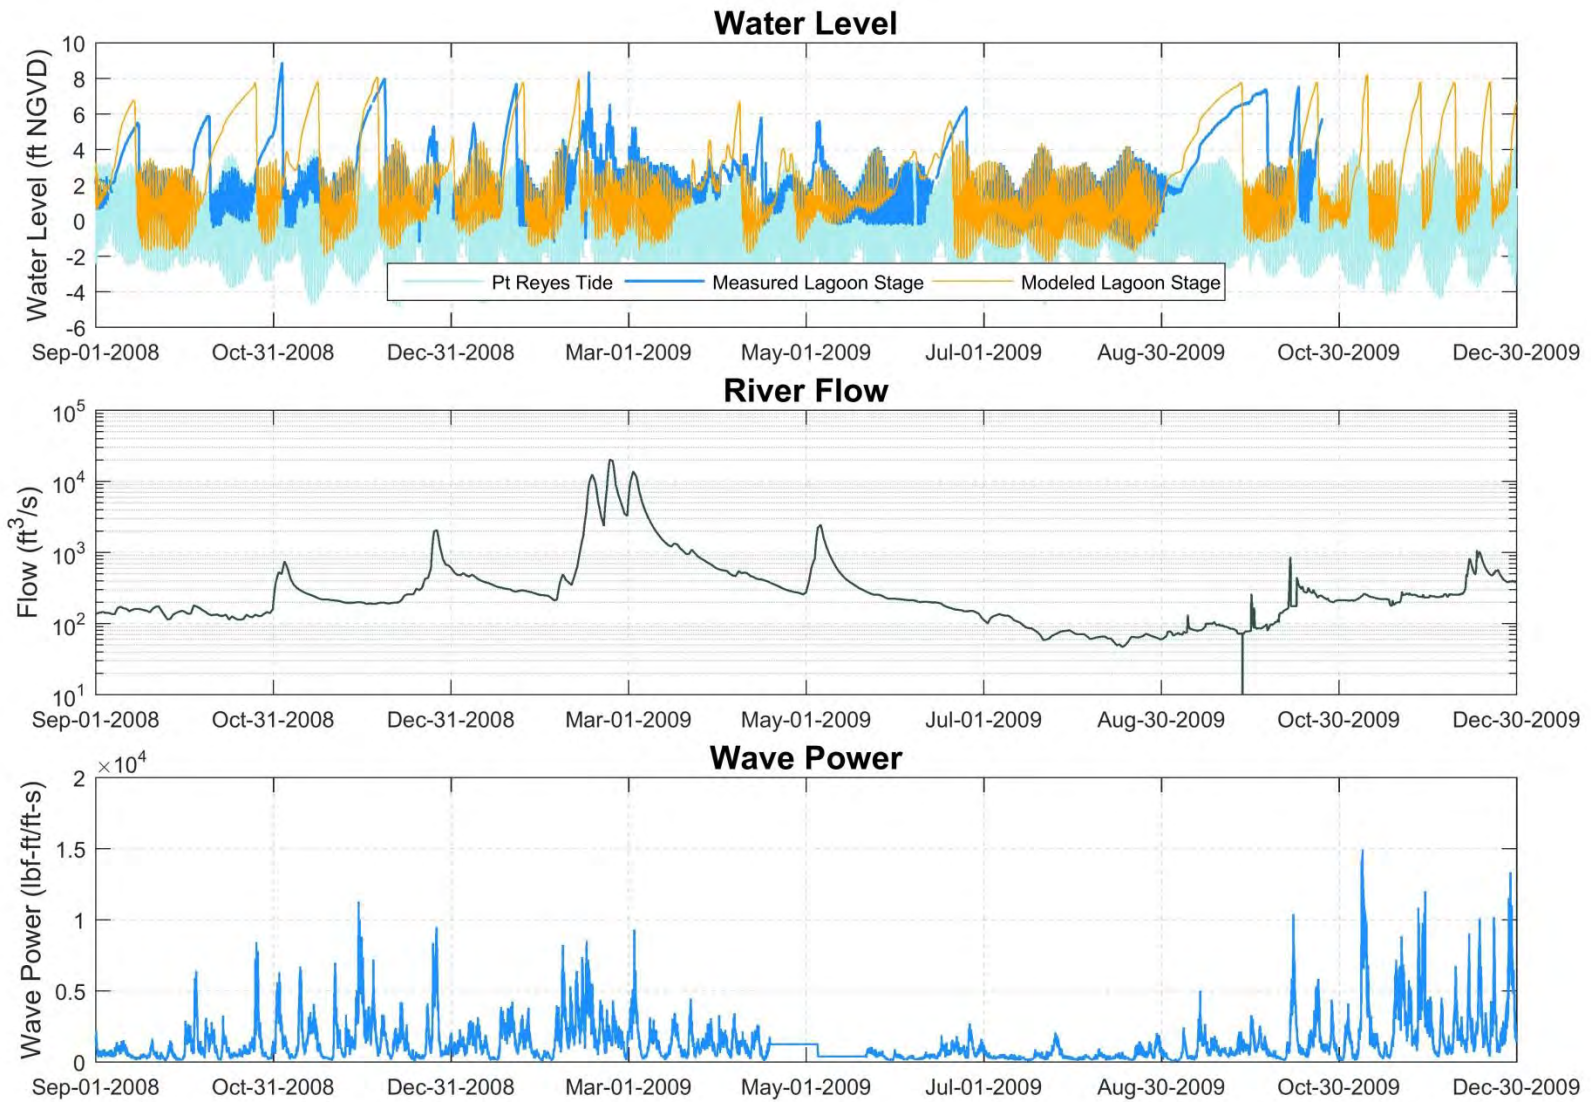
Test of QCM model accuracy in **(top)** predicting Russian River Estuary water levels, compared against **(middle)** river flow and **(bottom)** nearshore wave power for 2008-2009.

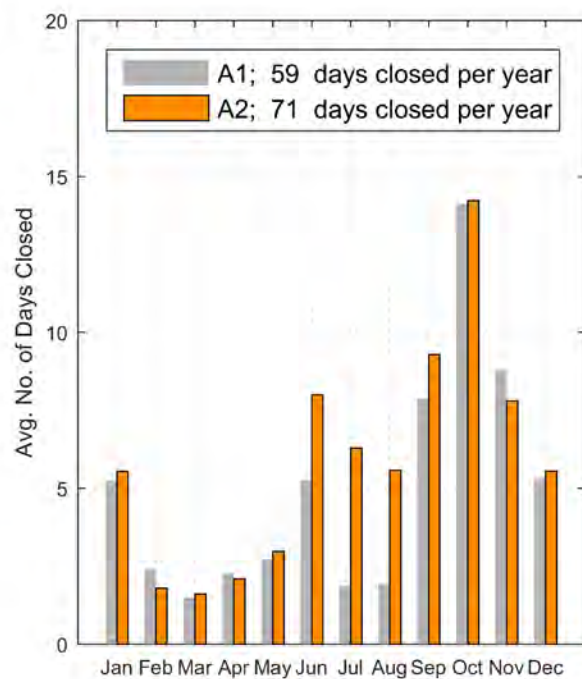
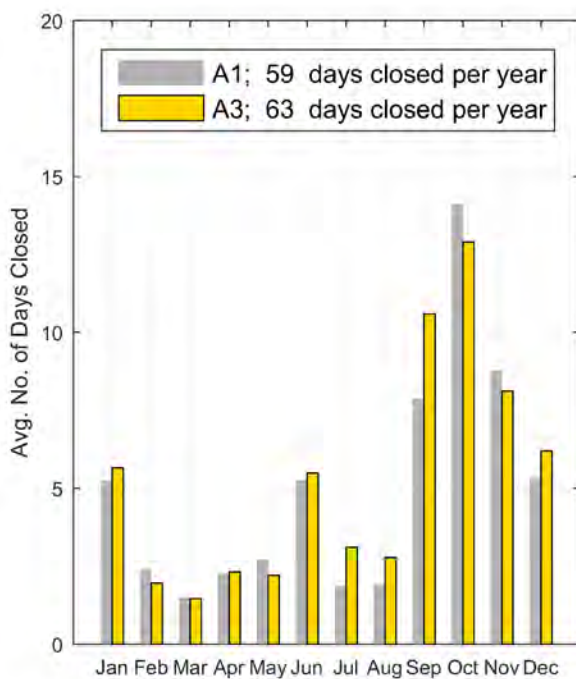
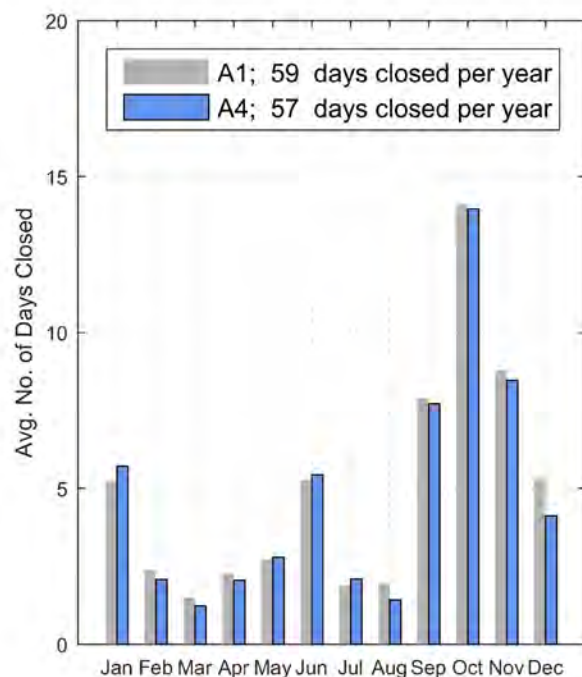
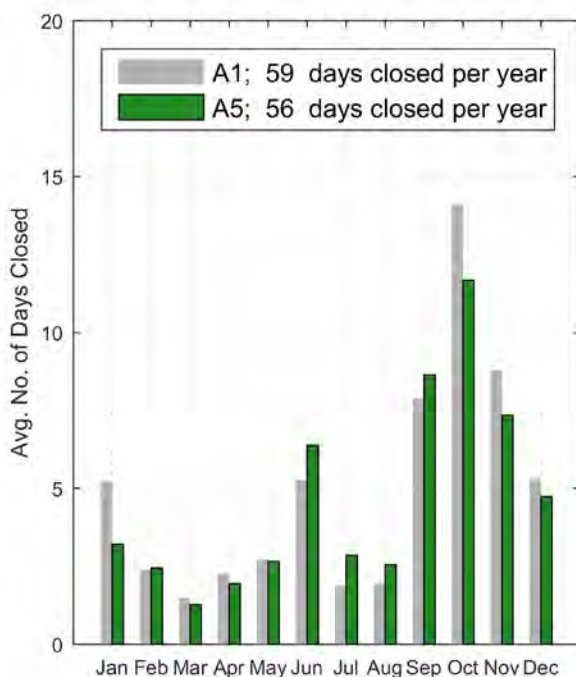
**Figure 9-2**

Comparison of the number of mouth closure days among jetty alternatives for years with different amounts of freshwater runoff.

SOURCE: ESA QCM model

Overall, compared to 59 days of closure per year for Alternative 1 (No Action), Alternative 2 is predicted to increase closure to 71 days per year, compared with 63, 57, and 56 days per year for Alternative 3, Alternative 4, and Alternative 5, respectively (Figure 9-3). None of the alternatives are predicted to change the water level enough to meet the goal of the Biological Opinion to attain 3.2 ft NGVD or higher water levels for 70 percent of the year (Figure 9-4). The alternatives' effect on days closed during the management period follows a very similar inter-annual pattern as the annual number of days closed (Figure 9-2).

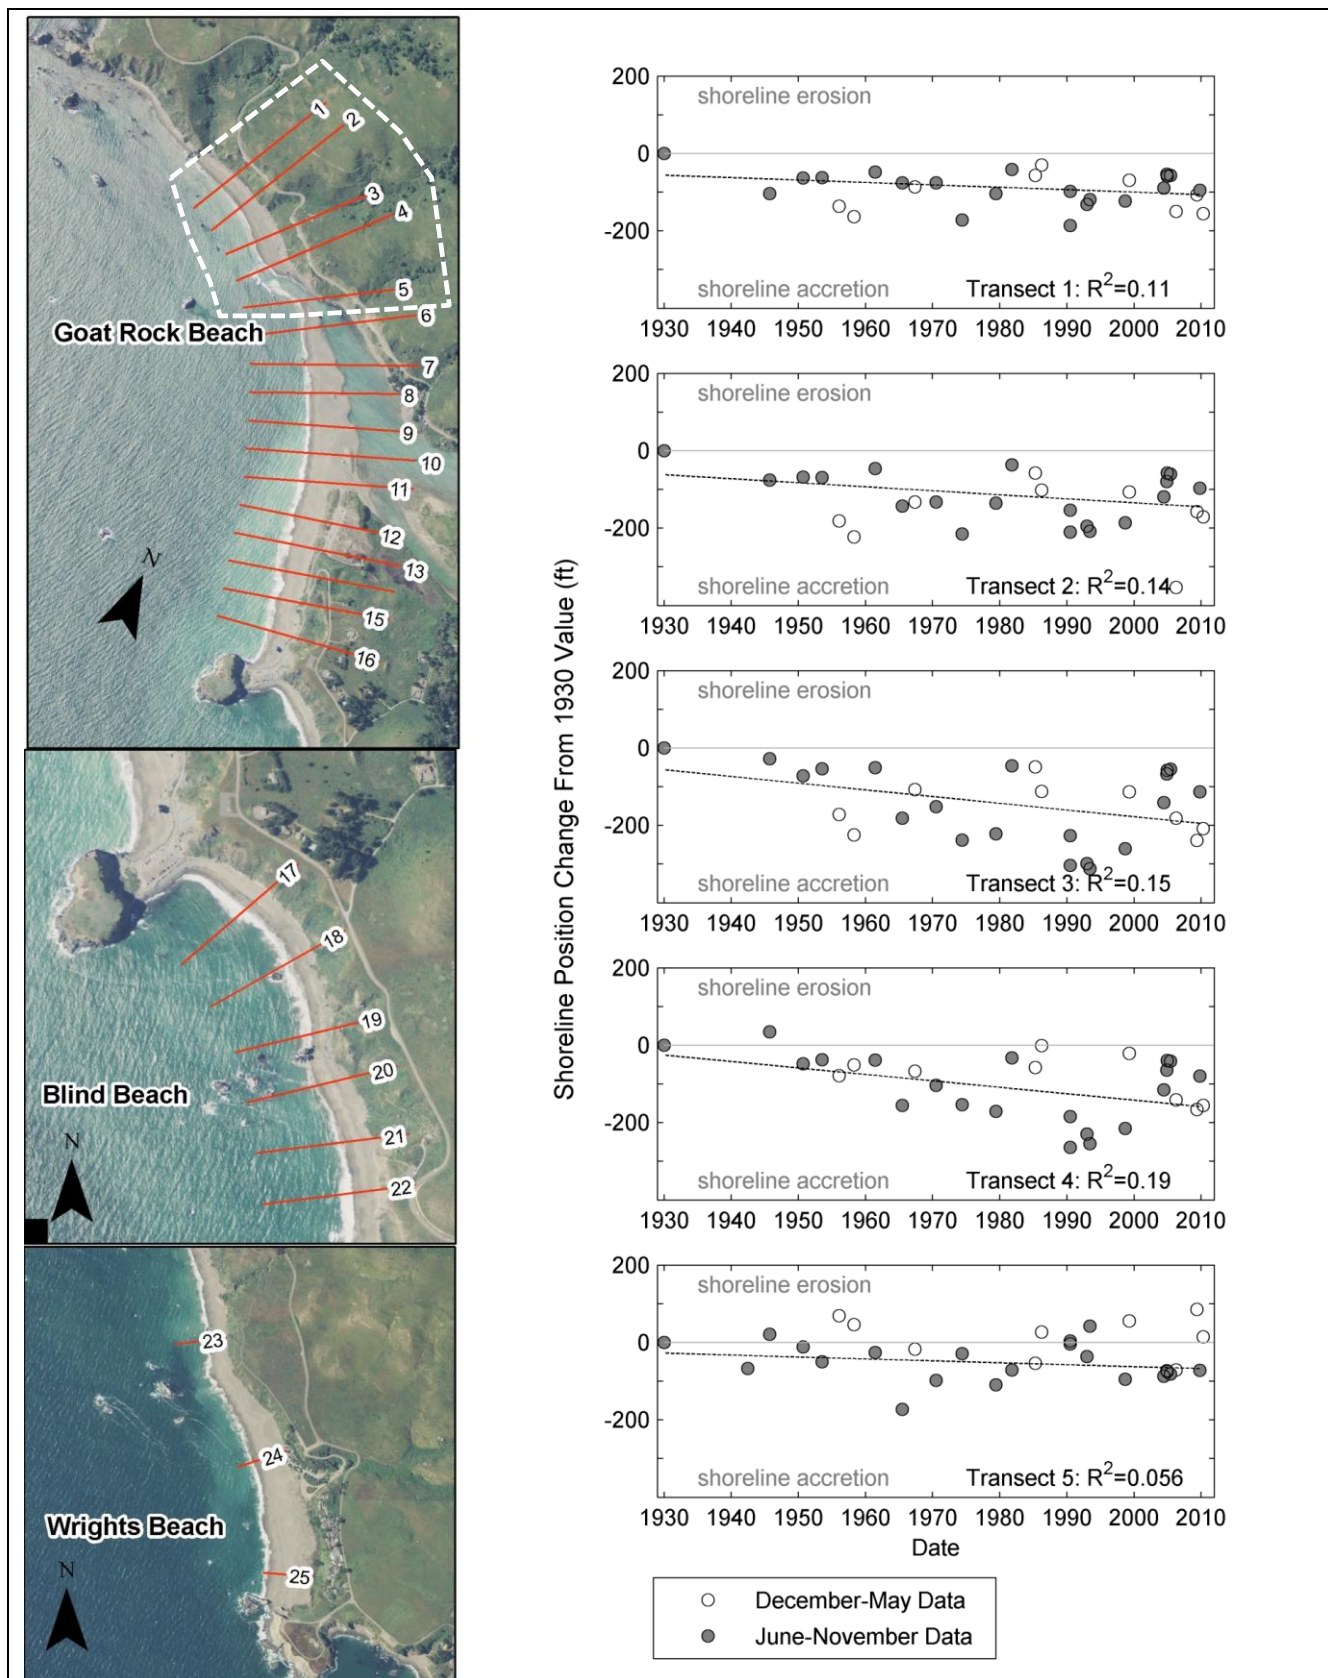
**Figure B-1**  
(left) Index of transects and (right) corresponding shoreline position data for transects 1-5.

NOTE: All linear trends were obtained using summer-fall data.
